## Cosmetic Concerns Provide Opportunity for Comprehensive Dentistry

Jeff Files, DDS

### ABSTRACT

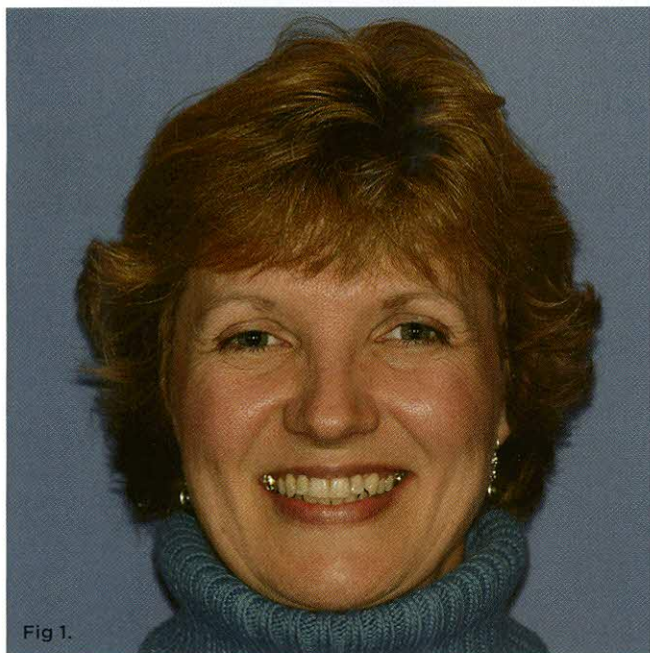
Fig 1.

**Fig 1.** The patient was unhappy with her smile. **Fig 2.** The patient's smile before treatment. Note the tooth mottling, gold display, uneven tissue levels, and malposed teeth.

A 44-year-old woman presented for evaluation and improvement of her smile. Her chief complaint was the unattractive gold display of her posterior crowns coupled with unsightly "white spots" on her anterior teeth (Figure 1 and Figure 2). Her compelling purpose for seeking treatment was to achieve a "great smile."
